IV EXISTING FACILITIES

The Main House at Ridge Hill was built in 1906 as a summer estate / hunting. The 8,993 square foot building (including a 1,324 square foot basement) has most recently been used for functions such as meetings, conferences, weddings and other social gatherings for up to 150 people.

The following is based on visual inspection of the building. An envelope study of the Ridge Hill Reservation Buildings (by Russo Barr Associates, Inc.) was completed in September 2006. Some of the following information is from that report.

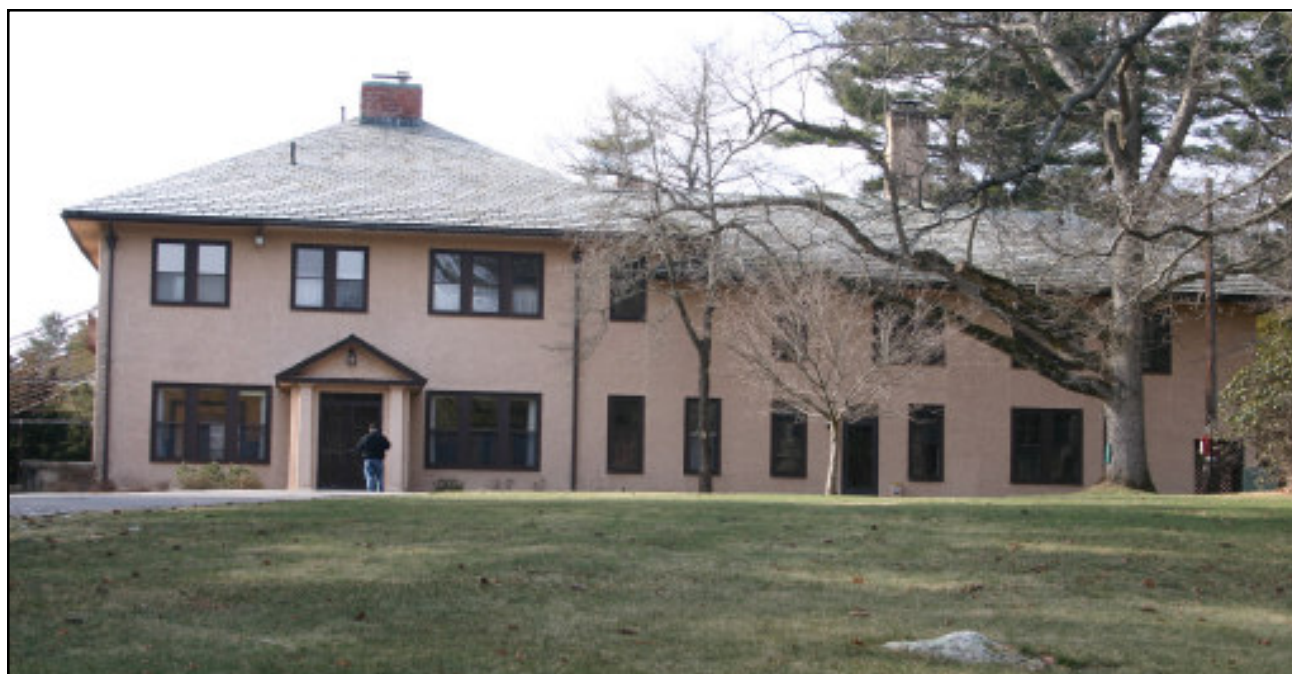
Figure 4.1 East Elevation.

The wooden rake board at the sun room has deteriorated. A recent repair to the wood fascia and stucco is evident on the eastern portion of the main house roof.

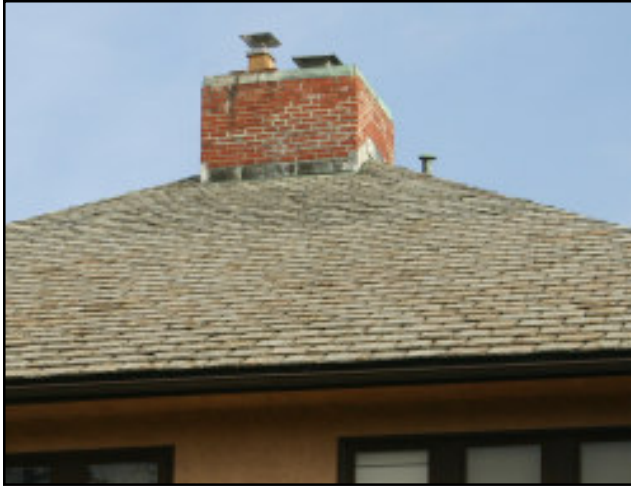
Figure 4.2 Slate roof and central brick chimney of main house.

The envelope study reported that the overall roofing system appears to be in good condition, although individual slates were loose or missing.

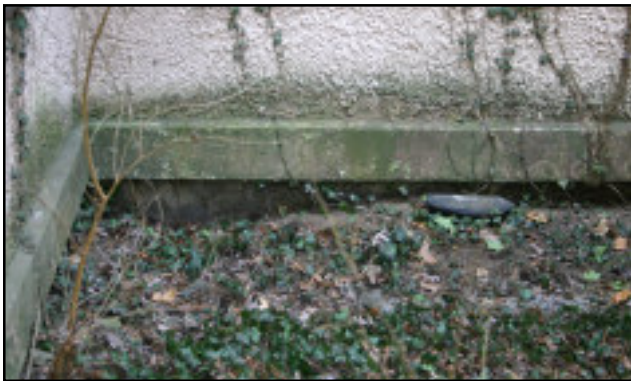
Figure 4.3 Effects of water backsplash at base.

The envelope study mentions the possible inadequacy of the existing residential-sized gutters on portions of the building, as contributing to water damage on the stucco wall near grade level. The gutter along the southern edge of the roof appears to have been bent and would need repair. Additionally, some leaders have become disengaged from the gutter.

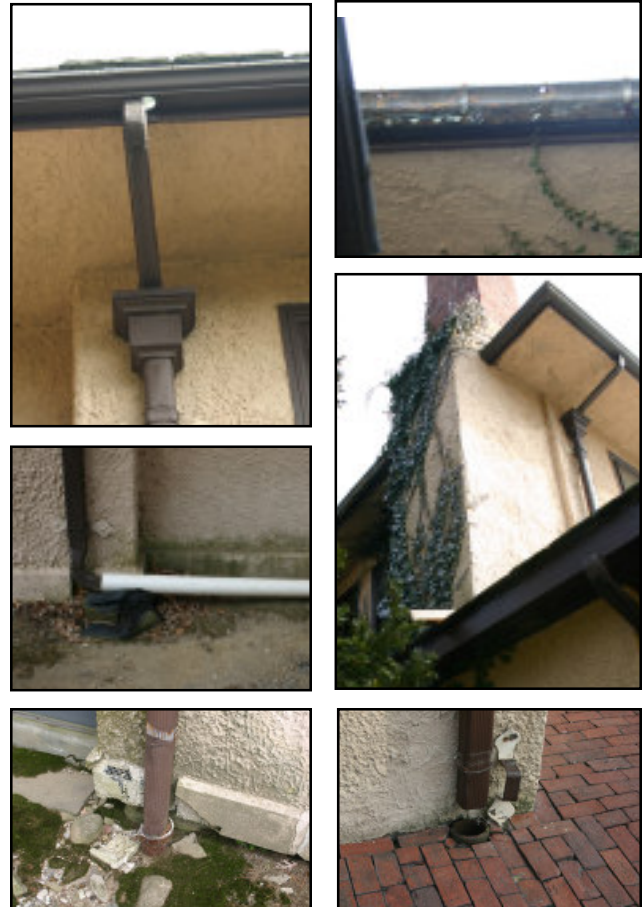
Figure 4.4

The exterior walls and roof soffits are a painted stucco finish. Based on visual inspection, the walls appear to be in fair condition, with evidence of water damage, particularly along the base and 9" high water table due to backsplash and where gutters are leaking. Further investigation will be

Clockwise from top left: Typical stucco eave and soffit detail and disengaged aluminum leader from aluminum gutter; copper gutter; ivy on stucco chimney base; disengaged leader from drainage sleeve; damaged stucco base; pvc pipe leader extender.

needed to determine the condition of the wall assembly behind the stucco. Ivy has been allowed to grow on the northwestern wall and chimney of the main house.

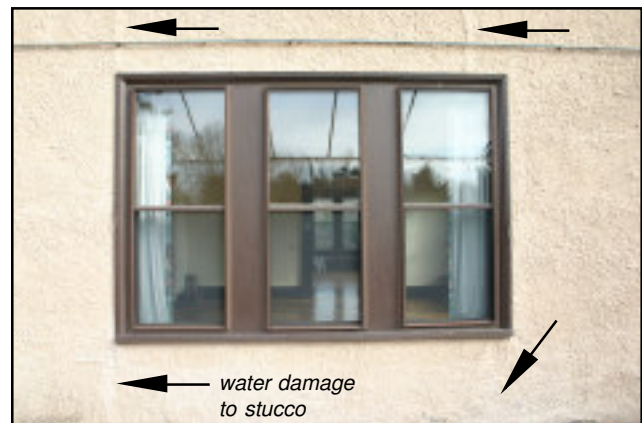
Figure 4.7 Typical set of windows in main house. Note single pane sash. Also note areas of water damage to stucco.

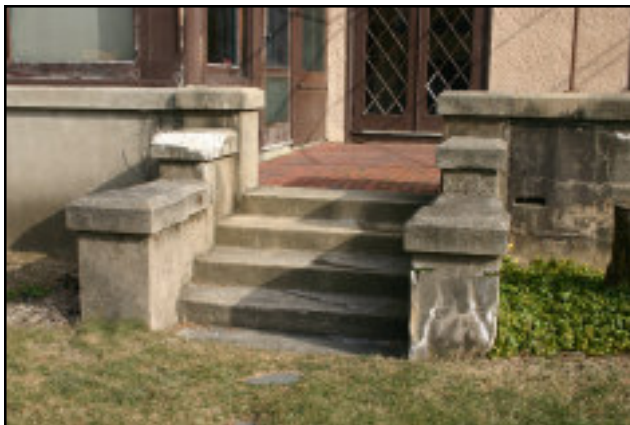
The 17" deep walls appear to be concrete parged over substrate (likely to be brick) with a 6 1/2" thick precast cap that has a 1" overhang. The top of the cap is +/-29" above the terrace. Areas of the wall and caps are cracked and spalling and will require restoration.

Figure 4.16 West terrace steps. Note cap spalling and wall deterioration.

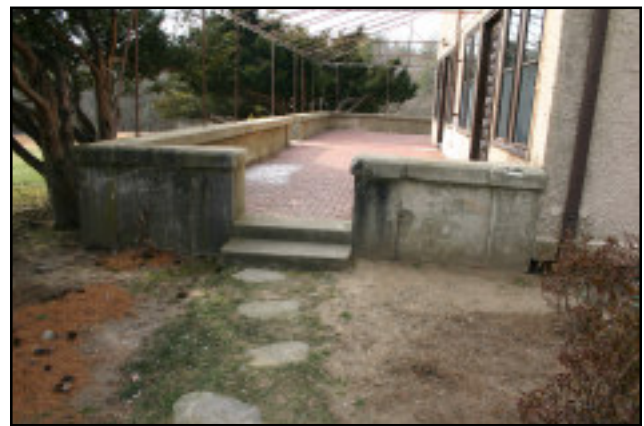
Figure 4.18 South terrace looking west. Note overgrown weeds on southern edge of wall.

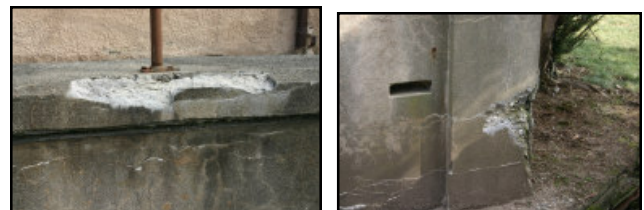
Figure 4.20 a & b: Damaged precast cap and parged wall.

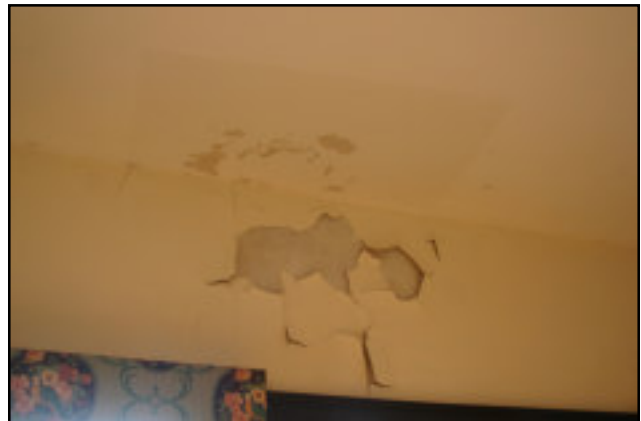
The walls and ceilings on the first and second floors are plaster over lath over wood framing. Peeling paint is evidence of water damage in the ceiling of the public function room. A painted wood wainscot lines the eastern public function room and continues up the open stair while the sun room walls are completely wood paneled. Wood trim and exposed beams are painted in the main house and dark stained in the service wing.

Figure 4.33 Water damage to wall and ceiling.

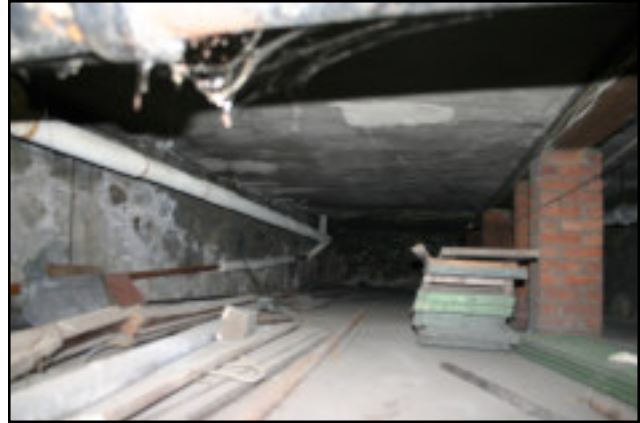
It is likely that there are hazardous materials in the building, particularly in the basement. Pipe and boiler insulation is likely to contain asbestos. Glazing compound in the windows may also contain asbestos.

Figure 4.44 Pipe insulation in crawlspace.

A hazardous materials investigation and analysis must be performed prior to or during the construction document phase to determine the exact scope.

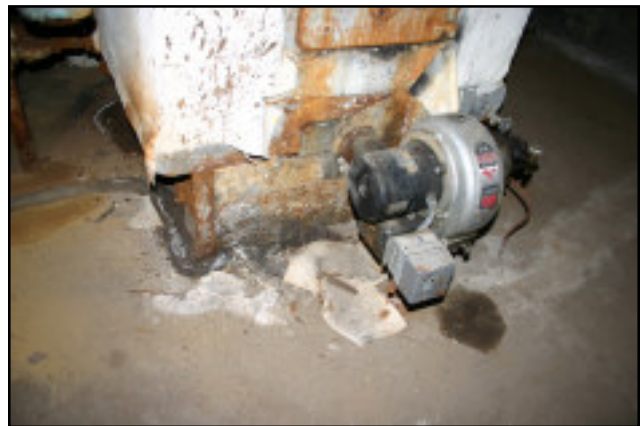
Figure 4.45 Insulation at abandoned boiler.
